Williamstown Meetinghouse Preservation Fund: building needs

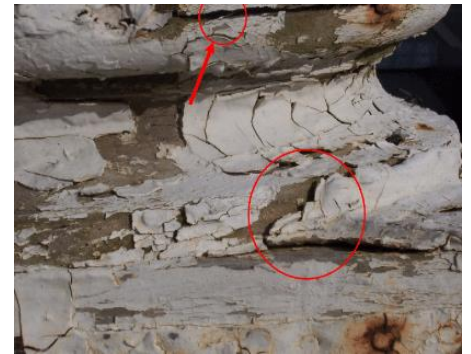
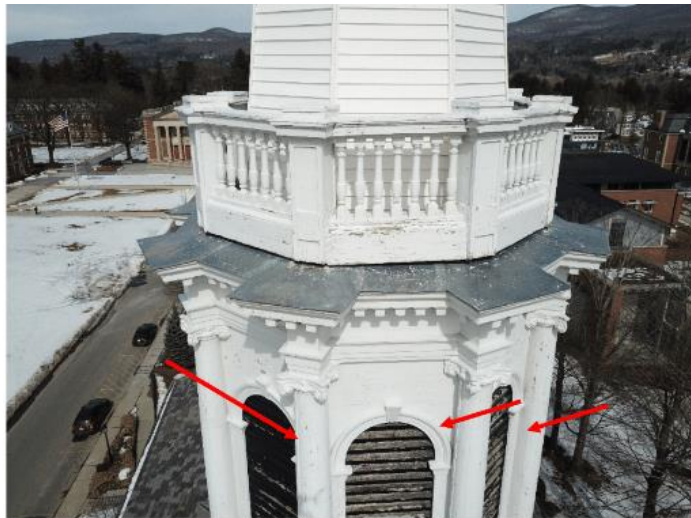
2. **STEEPLE RESTORATION:** The steeple needs significant restoration and is a site of significant water infiltration and damage to the finished areas below. The good news is that the steeple metalwork and wood structure is sound.
 - a. The open louvers of the two bell tower levels need to be removed and replaced. Significant water leakage is coming through these louvers. The new louvers need to be designed to prevent significant water or snow infiltration.
 - b. Floors at the two bell tower levels need assessment and repair due to water damage. The asphalt covering on the upper-level floors needs to be removed and replaced with an exterior grade EPDM (rubber) covering that is waterproof.

- c. Weathervane needs restoration
- d. Top Balustrade needs to be rebuilt
- e. Metal Roofing seams need EPDM cover tape, drops and kicks are needed on all drip edges and the roof flashing needs to be replaced
- f. Both plaster and wood details are degrading and need restoration before painting
- g. Spire is covered with siding which is not watertight. There is flashing below that is draining accumulated water. Further assessment is needed to ensure that water is not collecting beneath the siding.
- h. Lead Paint Precautions are necessary when working on the painted areas of the steeple
